USAAEFA PROJECT NO. 85-03

AIRWORTHINESS AND FLIGHT CHARACTERISTICS OF THE JOH - 58C (OH-58X SURROGATE) HELICOPTER

FEBRUARY 1986

FINAL REPORT

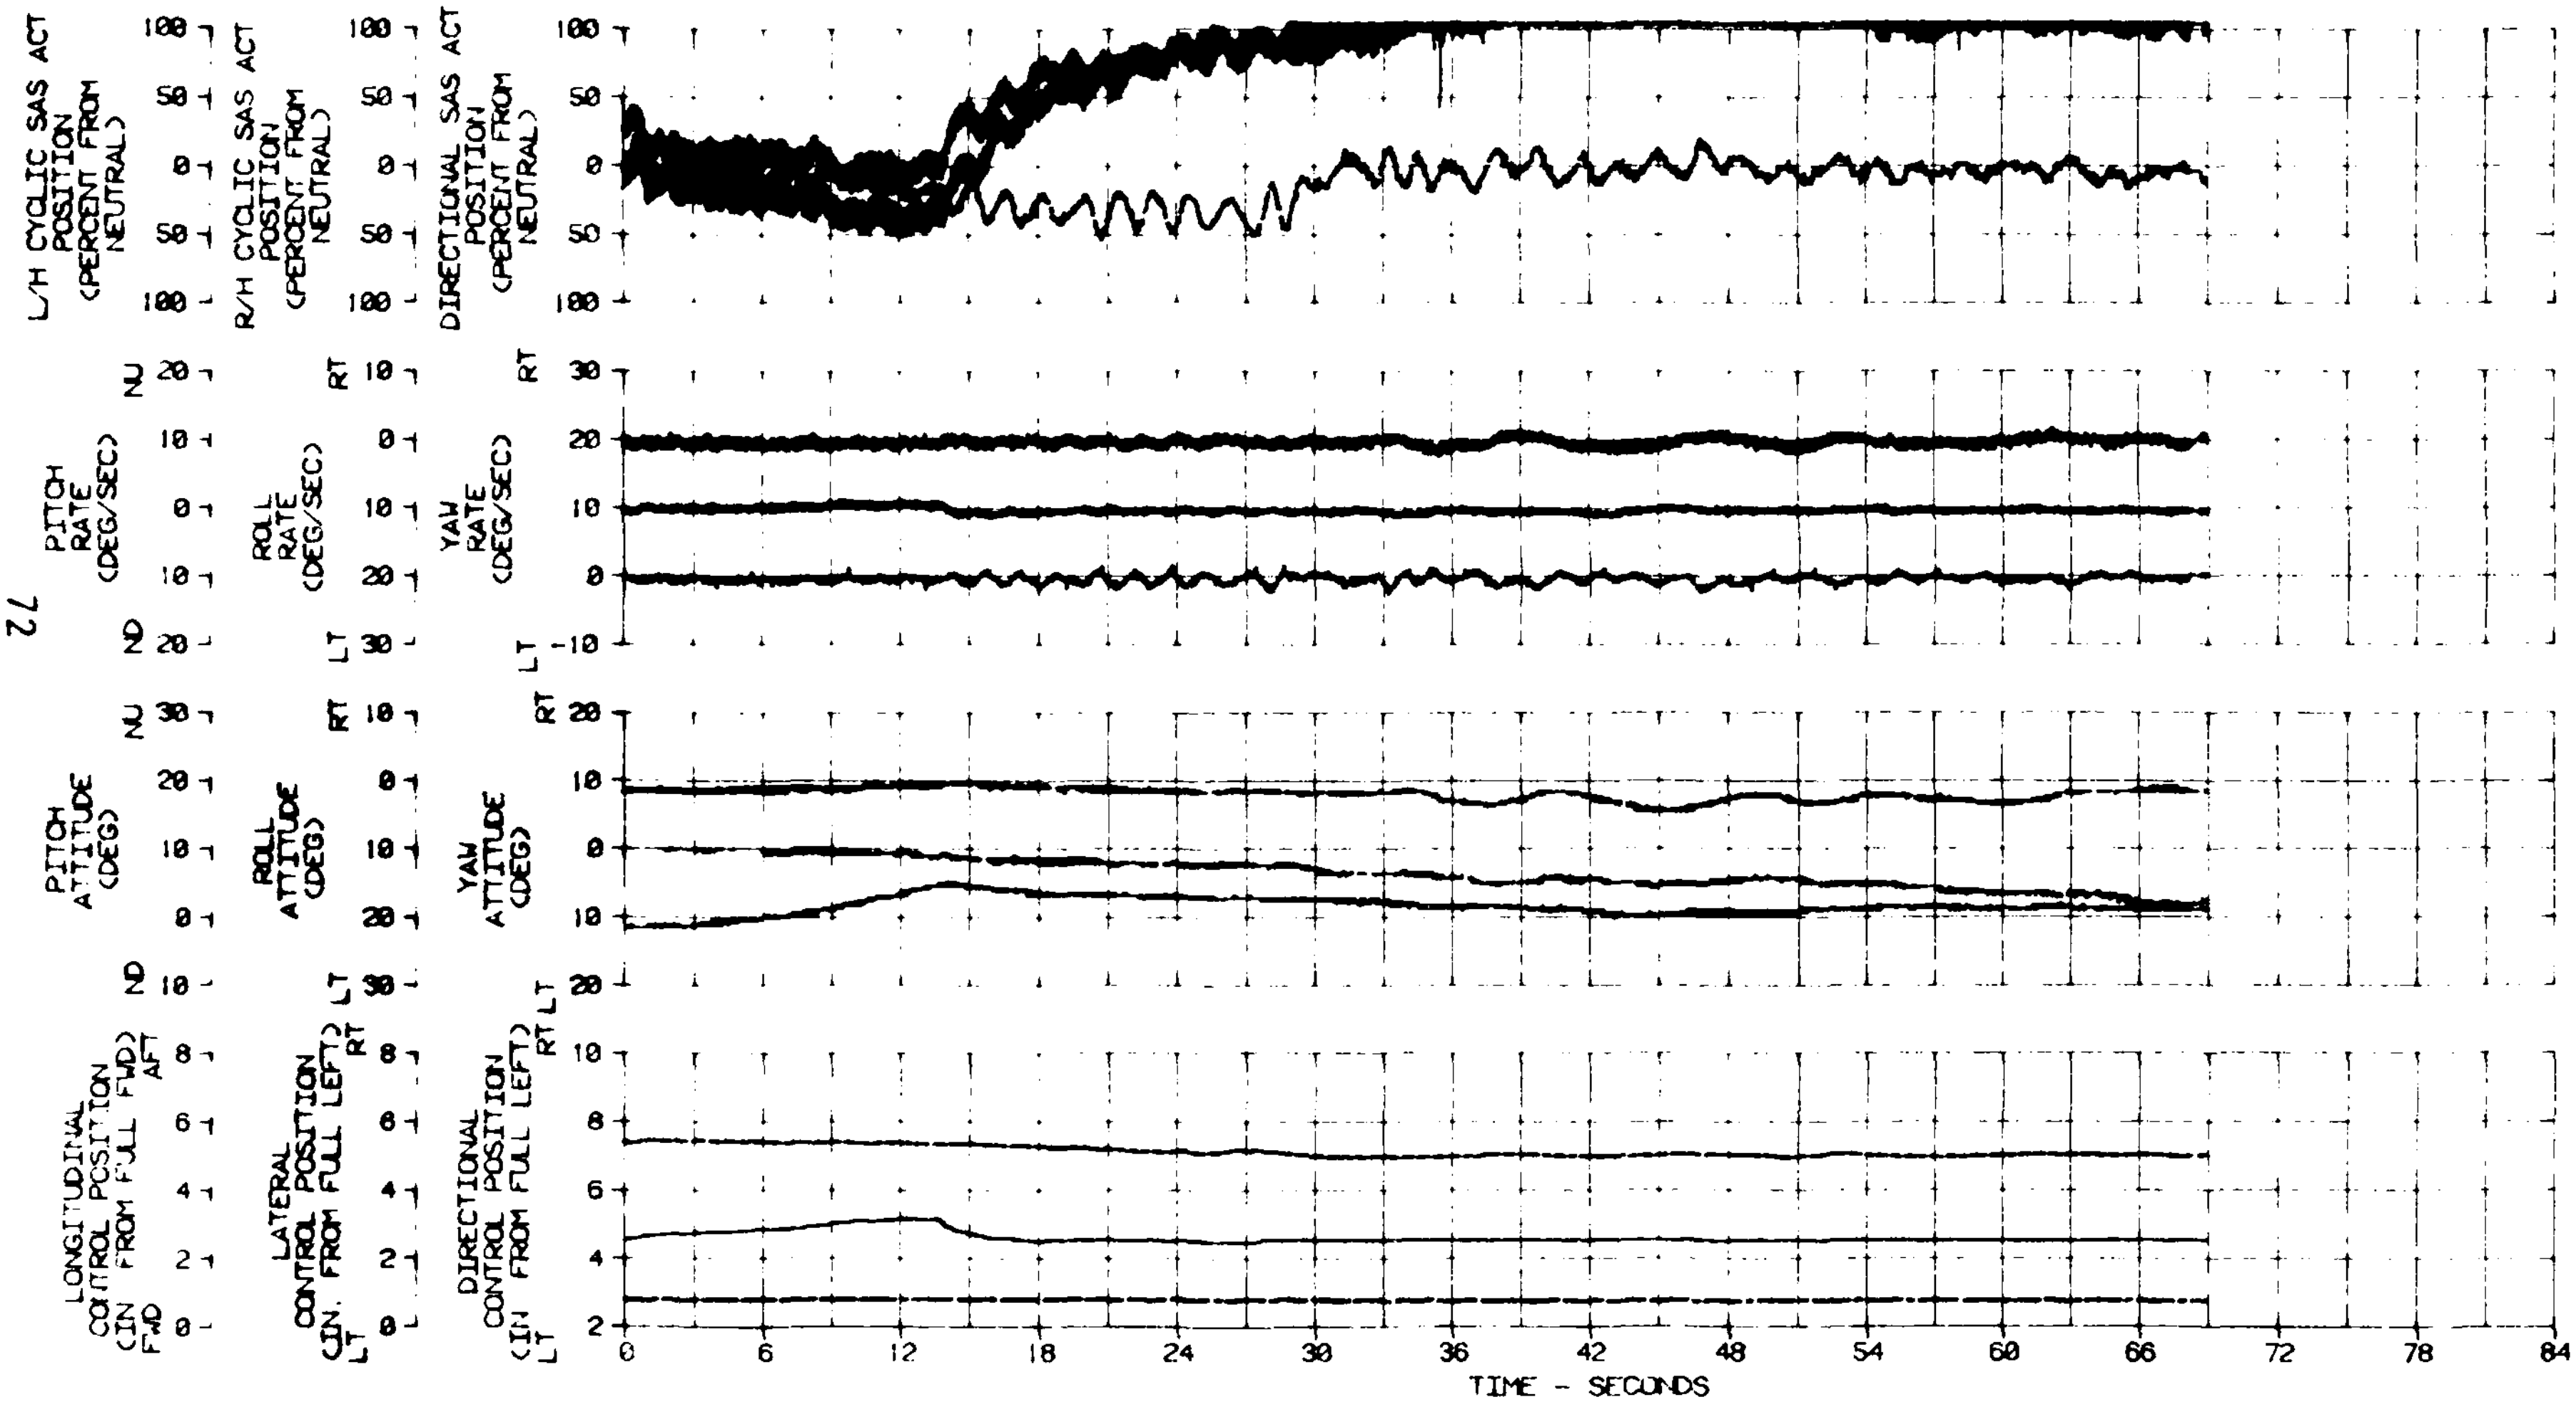
FIGURE 19
DIRECTIONAL CONTROLLABILITY
J0H-58C USA S/N 70-15349

18. Data for directional controllability characteristics in a hover are presented in figures 19 through 21, appendix E. The aircraft responded in the proper direction within 0.2 second after the input and no objectionable coupling was noted. The JOH-58C had increased yaw rate damping as compared to the standard OH-58C (ref 8, app A). Directional response was satisfactory and no tendency to overcontrol was noted. At the heavy gross weights tested, insufficient power margin required constant attention to torque limits with large (±1 inch) but smooth control movement to arrest right yaw rate. The directional controllability characteristics of the JOH-58C are satisfactory.

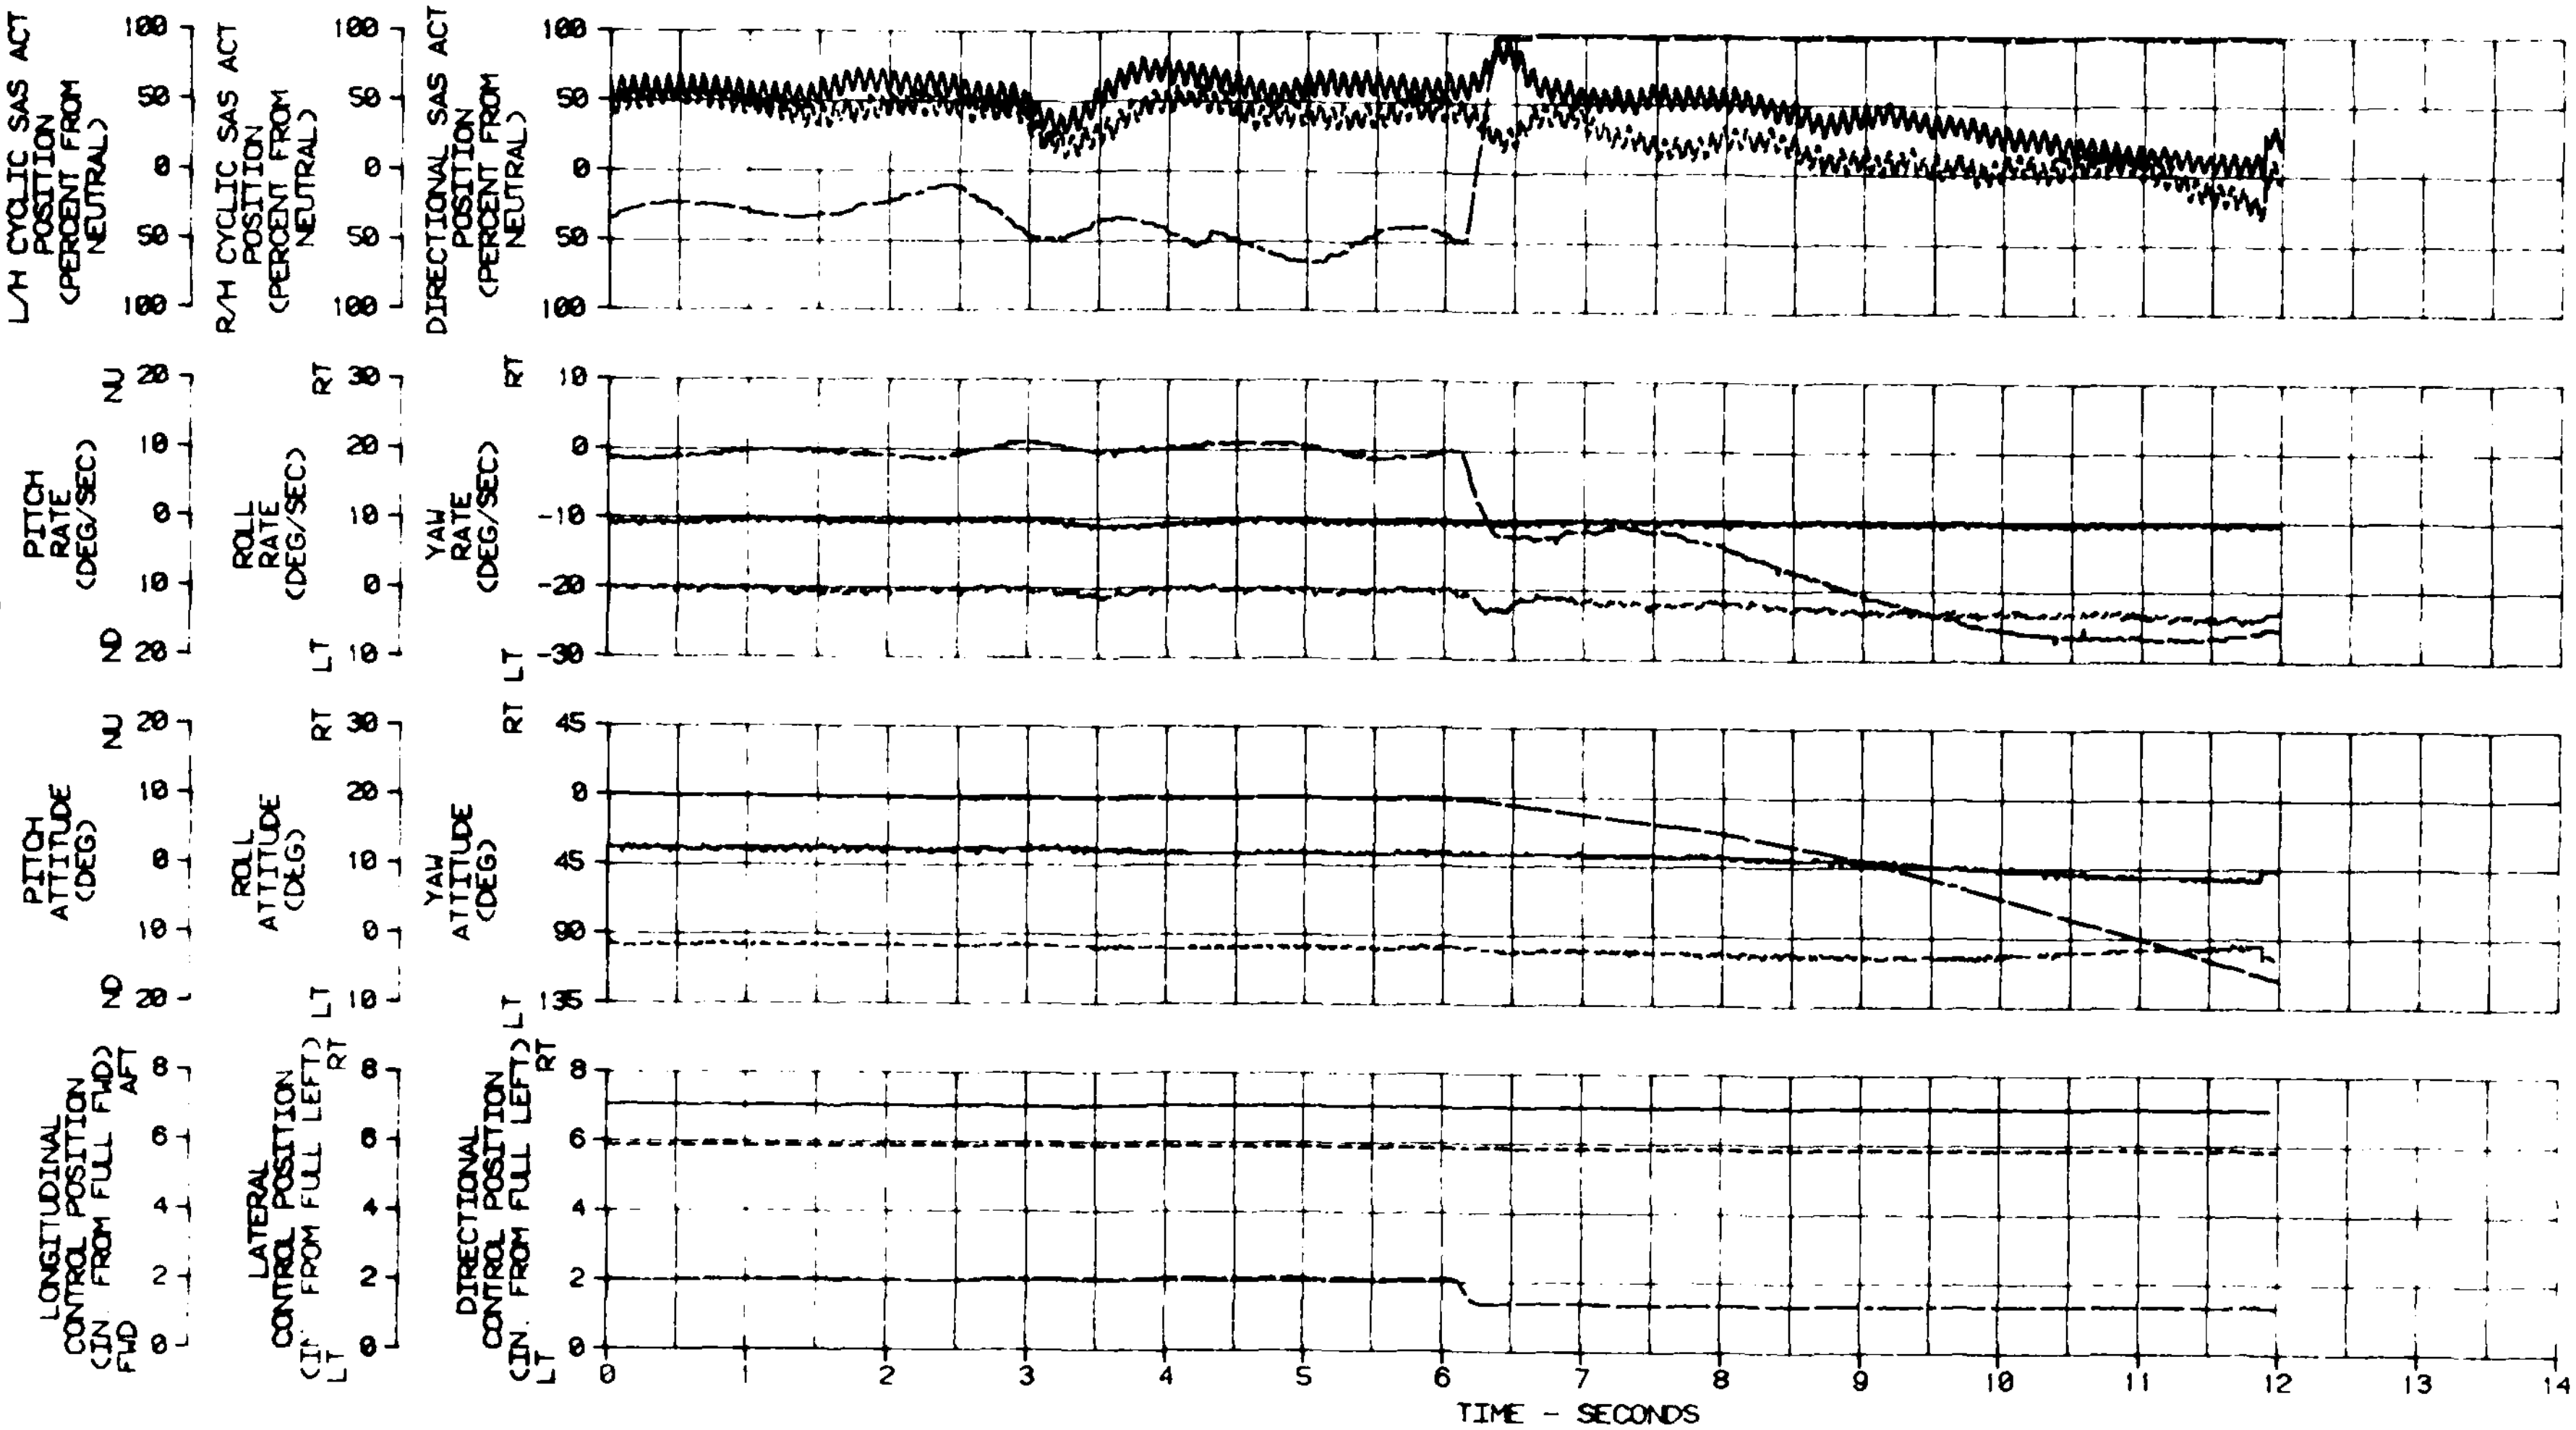
FIGURE 22
LONGITUDINAL CONTROLLABILITY
JOH-58C USA S/N 70-15349

19. The longitudinal controllability characteristics of the JOH-58C were evaluated at a hover and at 90 knots calibrated airspeed (KCAS) at the conditions listed in table 1. Longitudinal controllability data are presented in figures 22 through 25, appendix E. The aircraft responded in the appropriate direction within 0.2 sec with no objectionable coupling. With inputs up to approximately 2 inches, the longitudinal response was sufficiently damped, resulting in a shorter time required to achieve a steady state rate. The pilot will have predictable and adequate longitudinal control response and will not have to focus increased attention on pitch attitude control. The longitudinal controllability characteristics of the JOH-58C are satisfactory.

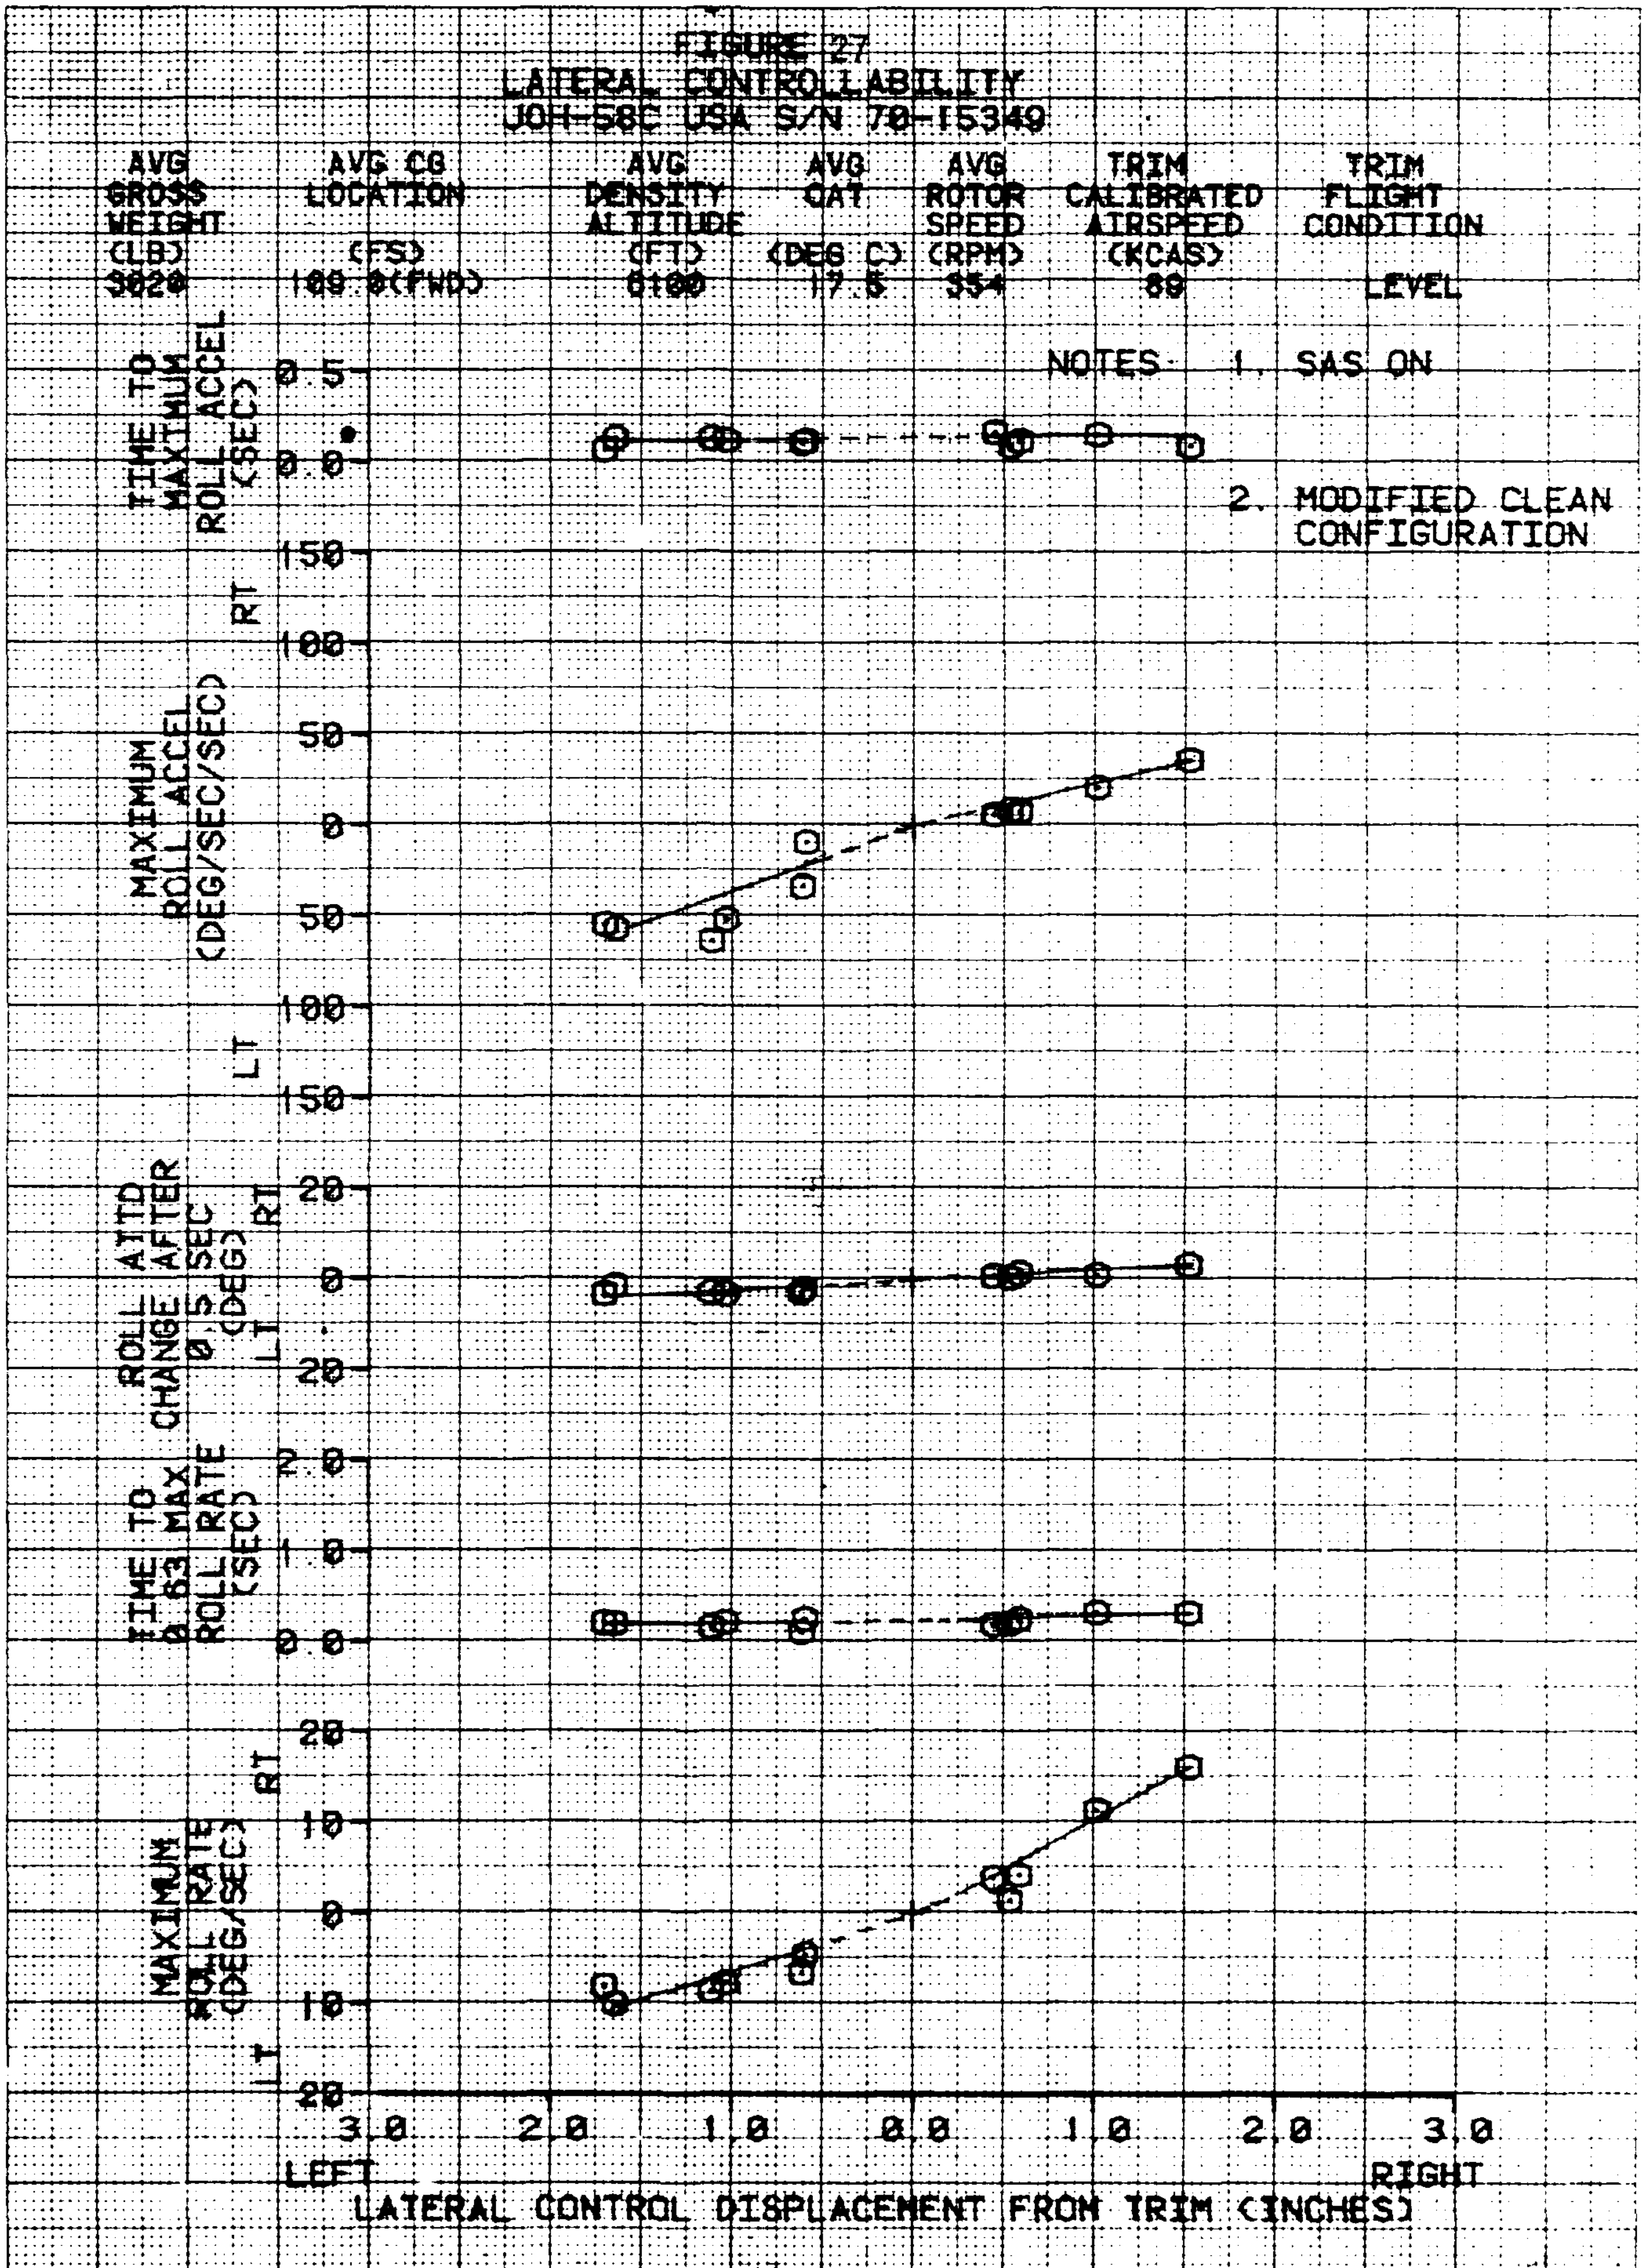
20. Lateral controllability characteristics of the JOH-58C were evaluated at a hover and at 89 KCAS at the conditions listed in table 1. Lateral controllability data are presented in figures 26 and 27, appendix E. The aircraft responded in the appropriate direction within 0.2 sec with no objectionable coupling. The aircraft exhibits predictable lateral response primarily because of the quick achievement of steady state rates in response to control displacement. The lateral response of the JOH-58C was qualitatively more damped than the standard OH-58C. The lateral controllability characteristics of the JOH-58C are satisfactory.

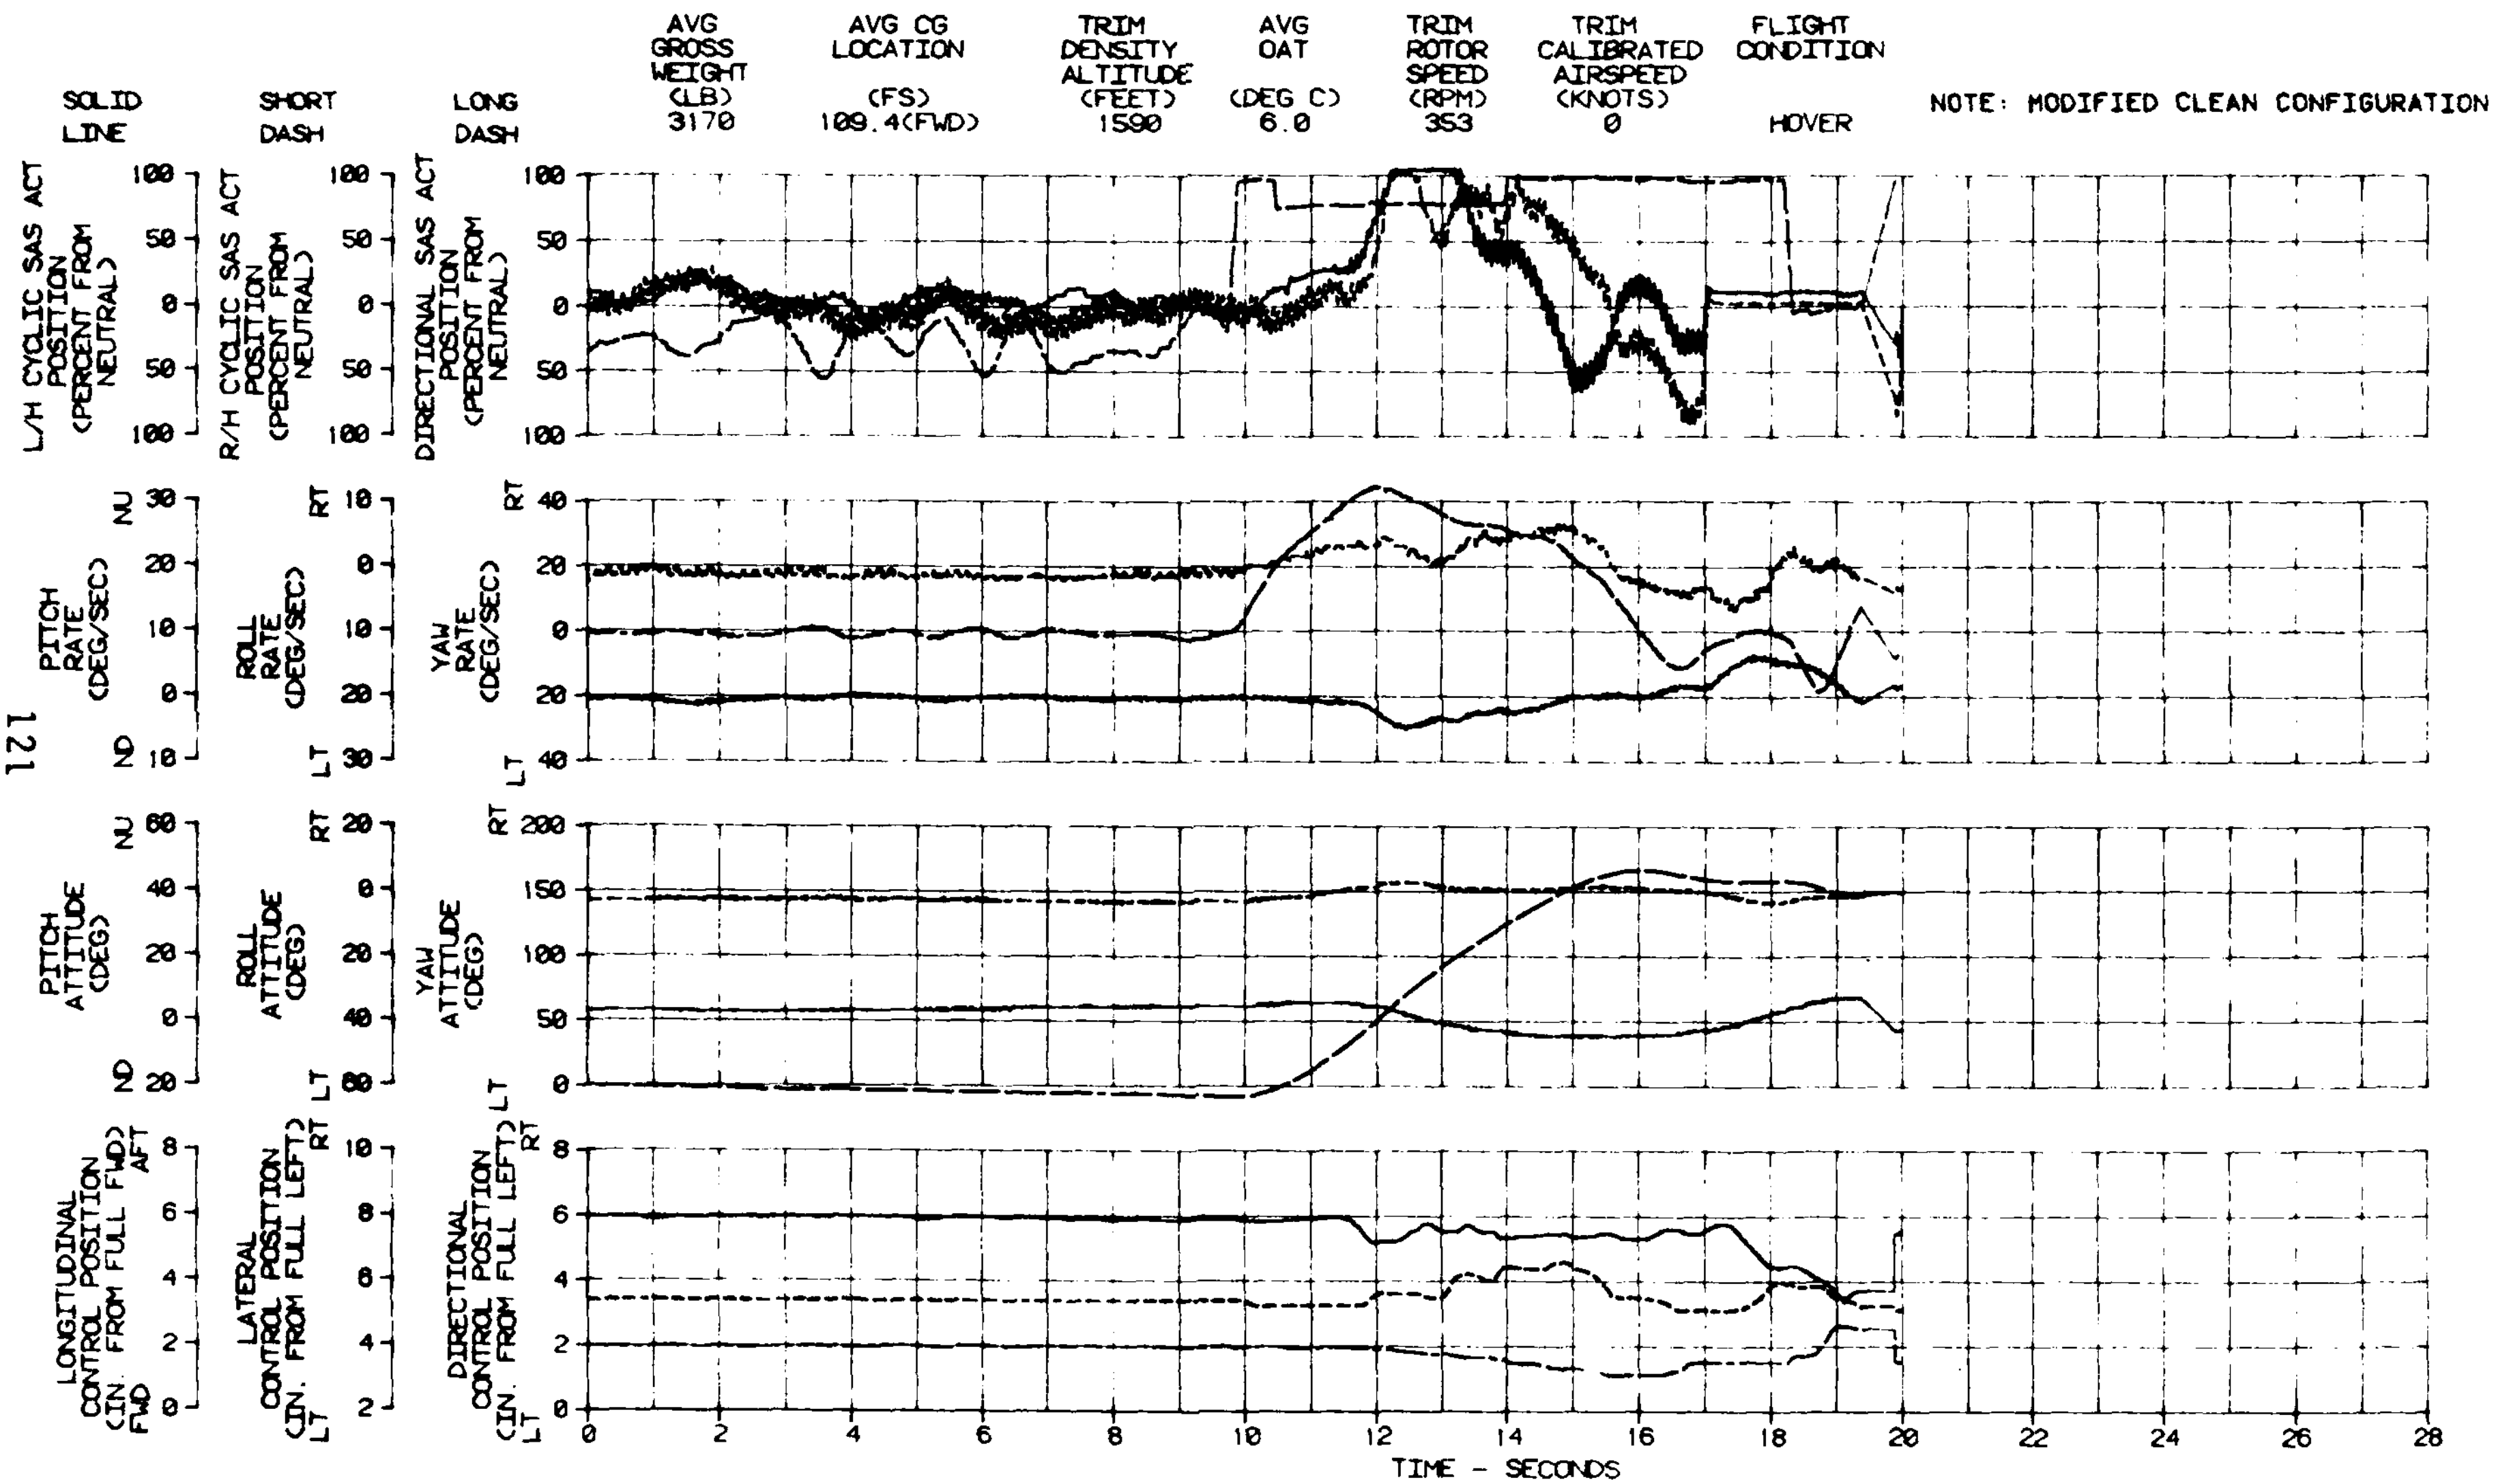
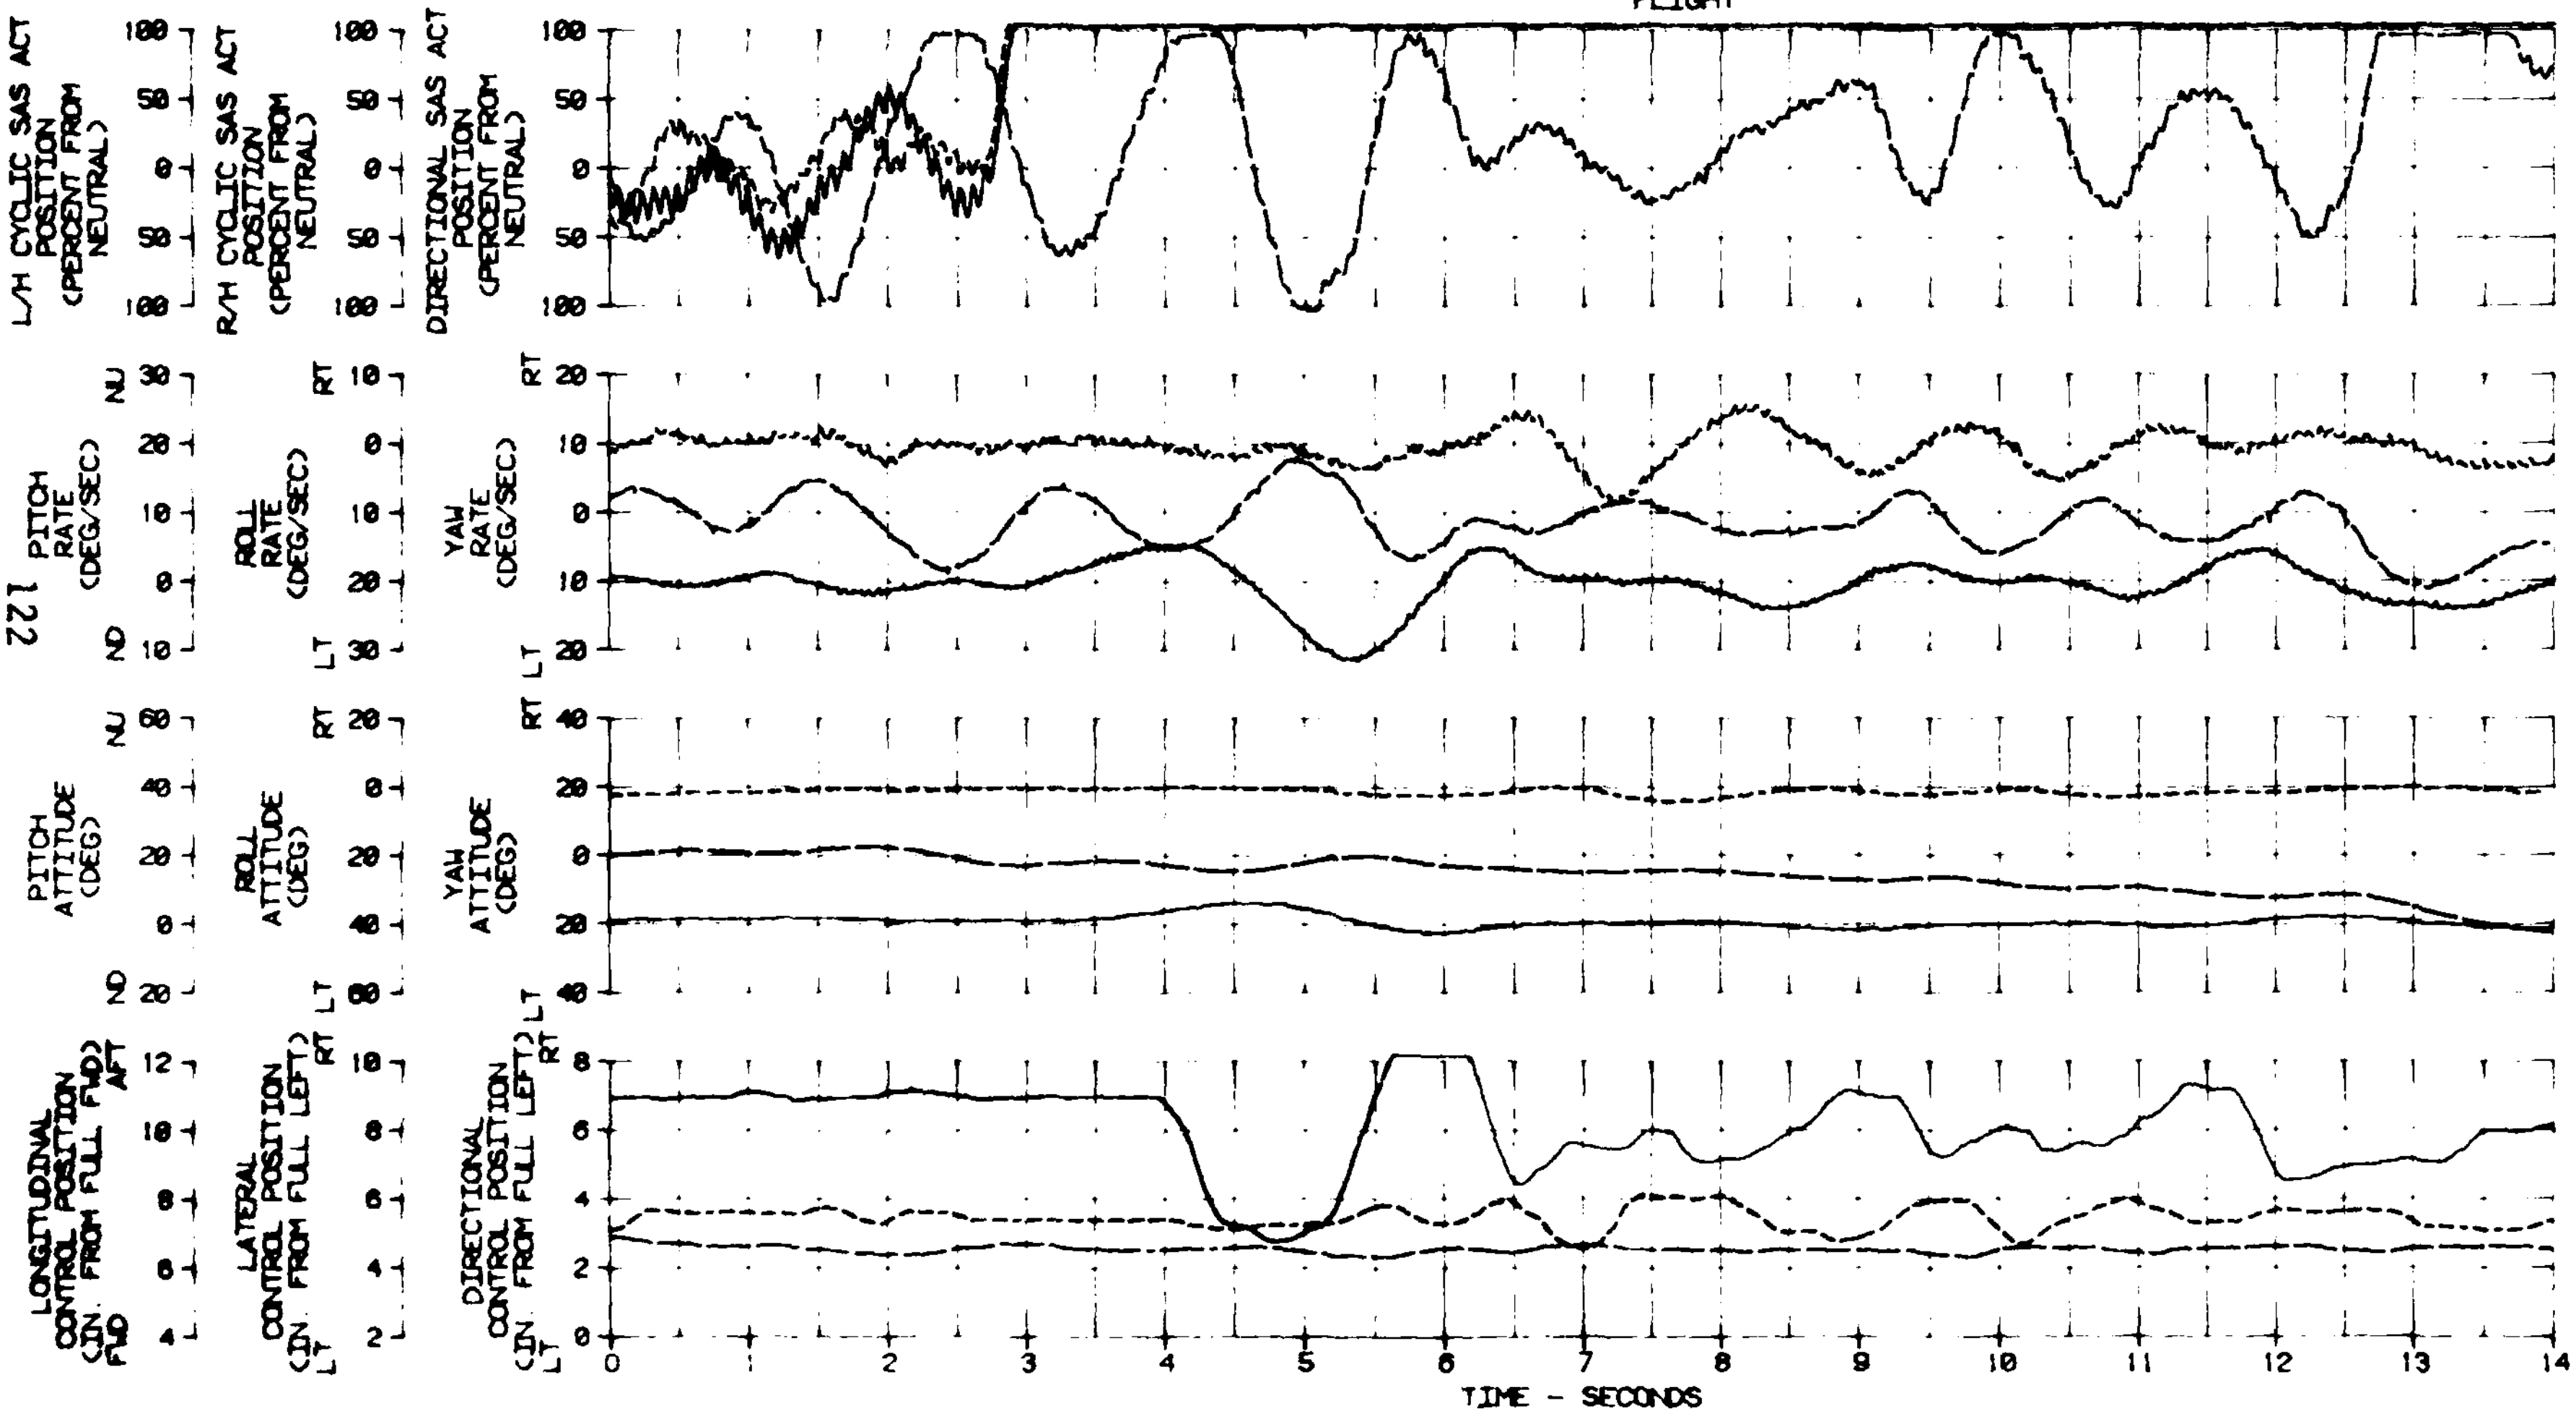
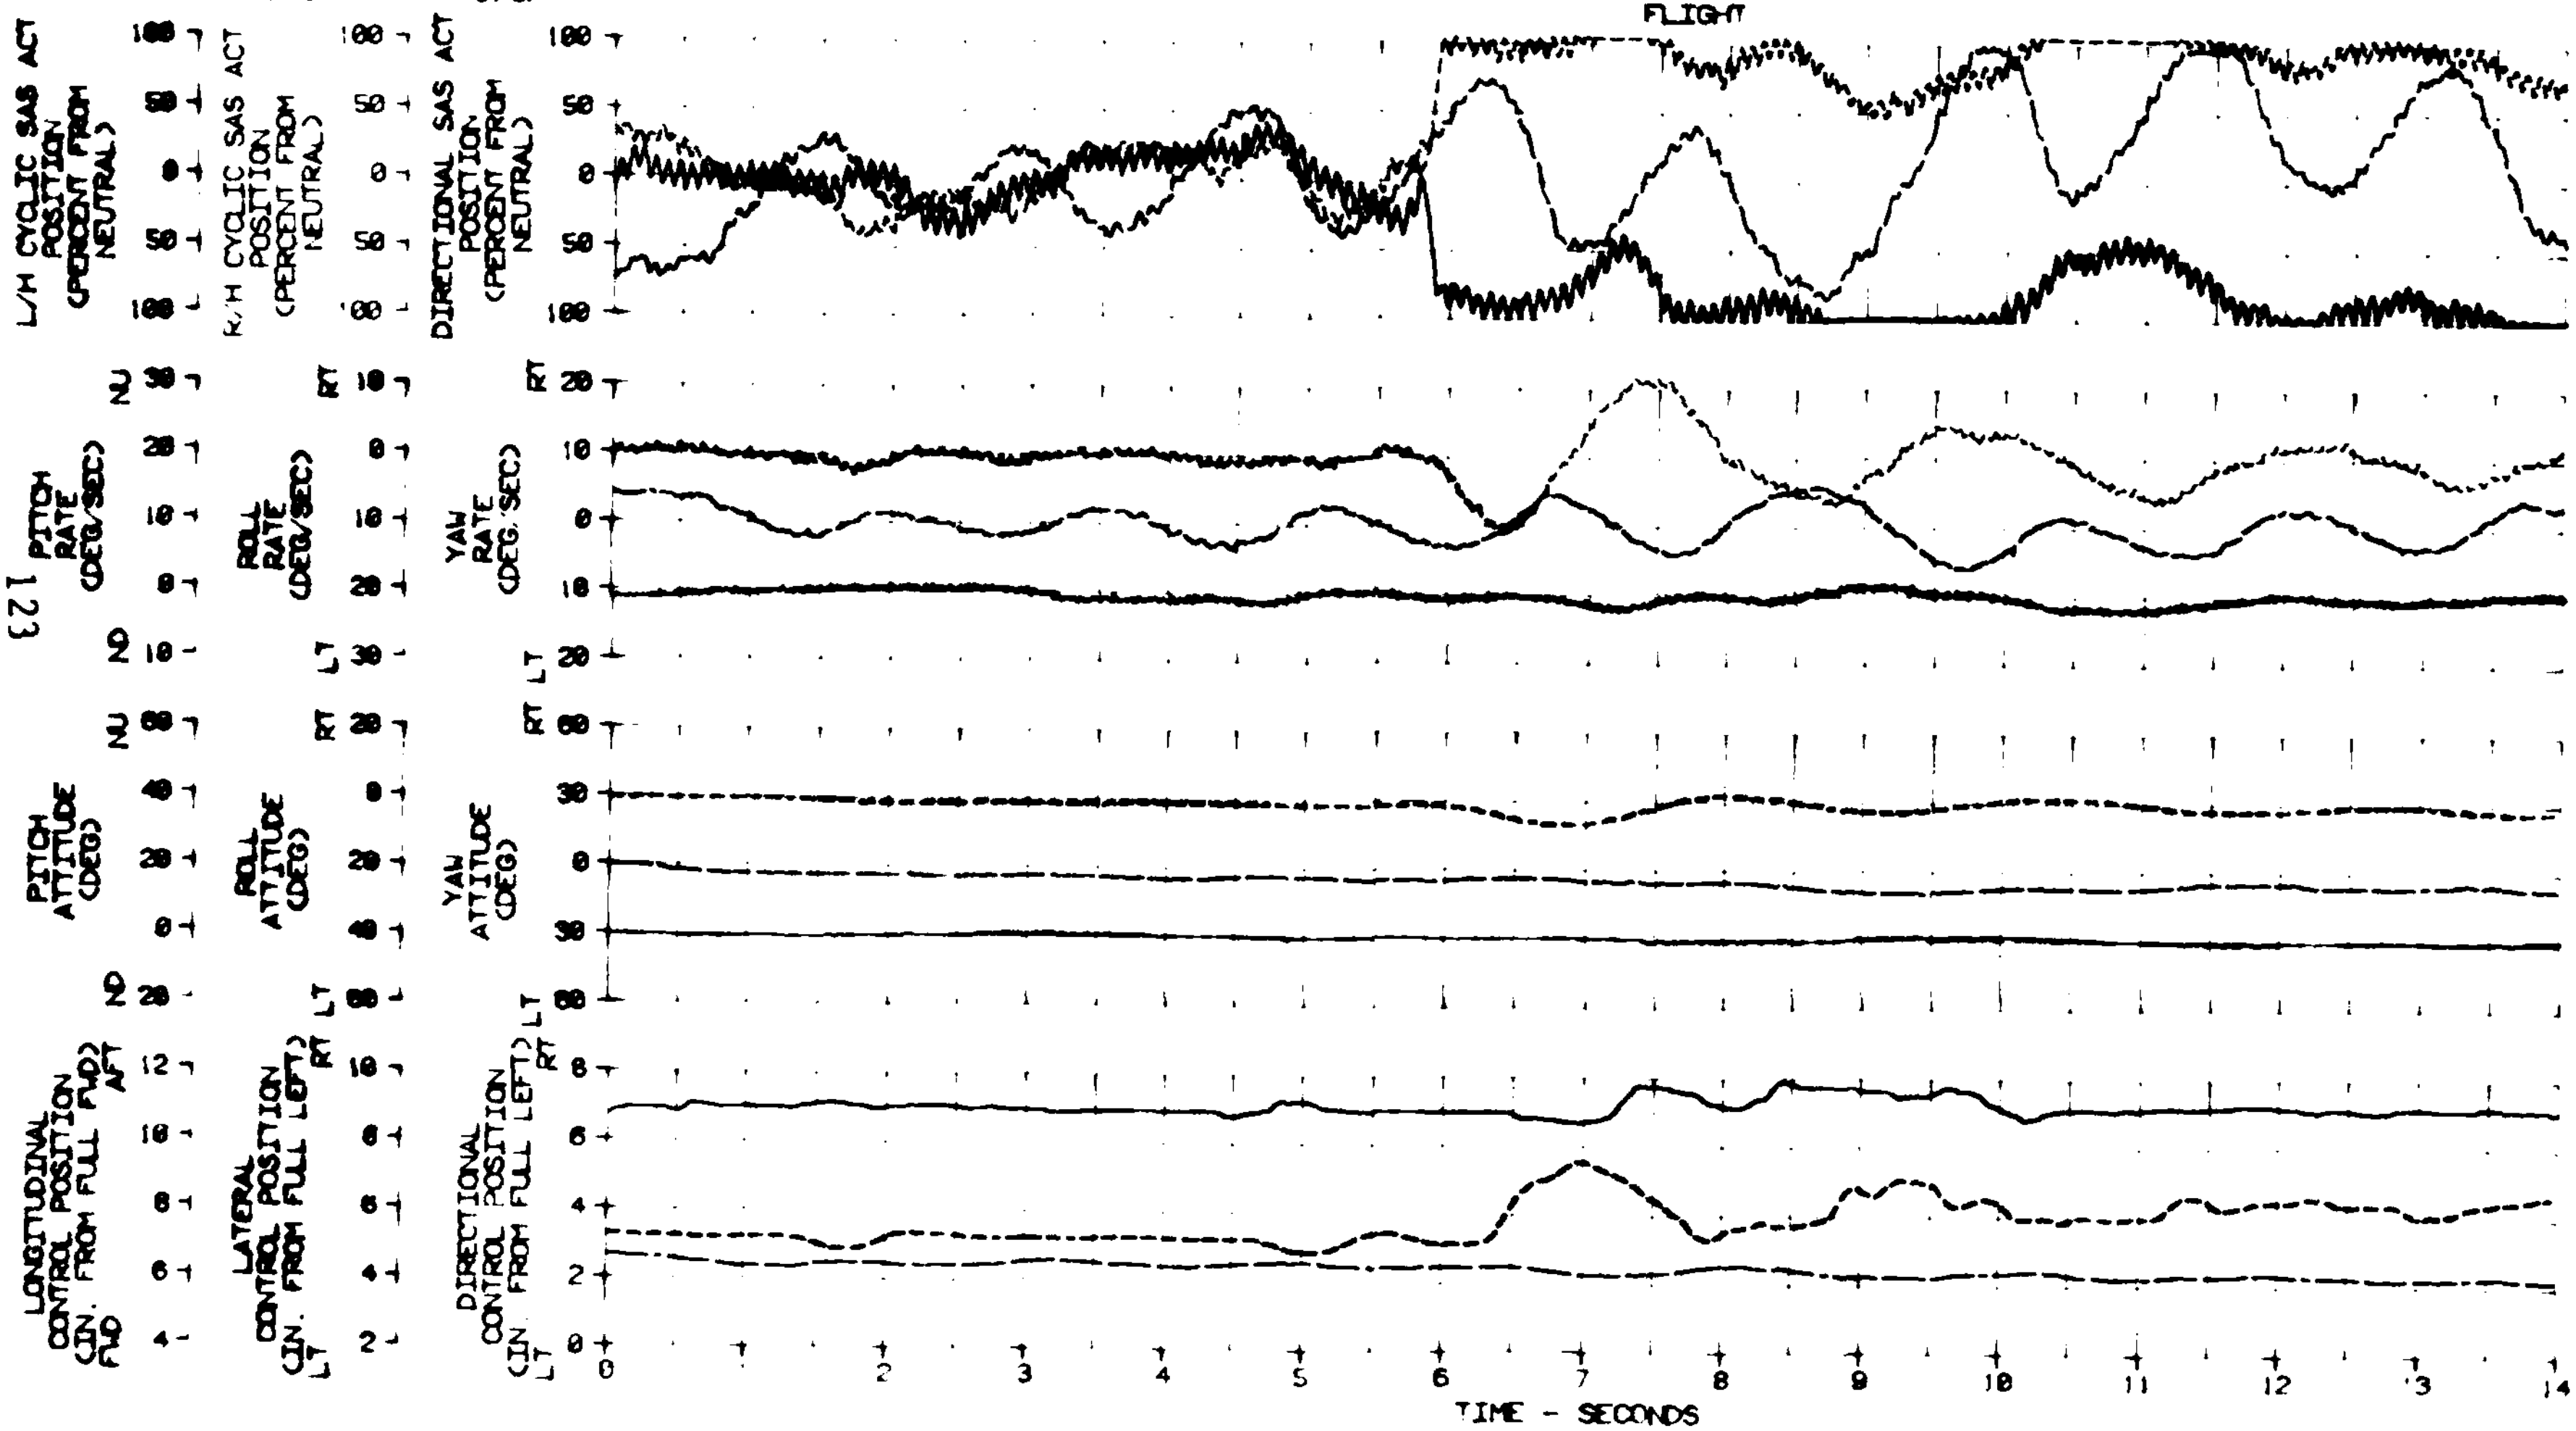
FIGURE 68
PITCH SAS HARDOVER
240 DEG. AZIMUTH, 15 KTS
JOH-58C USA S/N 70-15349

32. SAS hardovers during low speed flight at the critical azimuth/speed were also accomplished (figs. 68 through 70, app E). With zero delay time, the aircraft produced mild reactions which were similar to those produced with zero time delay at a hover (para 31). The initial acceleration provided inadequate cues that a hardover had occurred. No significant rates or attitude changes developed and minimum pilot compensation was required to maintain heading and attitude criteria. SAS hardover characteristics during low speed flight at the critical azimuth/speed are satisfactory.
